Dam ID: HI00030

Date: 18 March 2006 (Rev)

**STATE OF HAWAII - DLNR
VISUAL DAM SAFETY INSPECTION SHEET**

Dam/Res. Name	<u>Ka Loko</u>	
Owner	<u></u>	
Owner Contact	<u></u>	Owner Ph. <u></u>
Lessee	<u></u>	Lessee Ph. <u></u>
O & M Contractor	<u></u>	O & M Ph. <u></u>
Nearest City	<u>Kilauea</u>	Latitude <u></u> ° (decimal)
County	<u>Kauai</u>	Longitude <u></u> ° (decimal)
Tax Map Key(s)	<u></u>

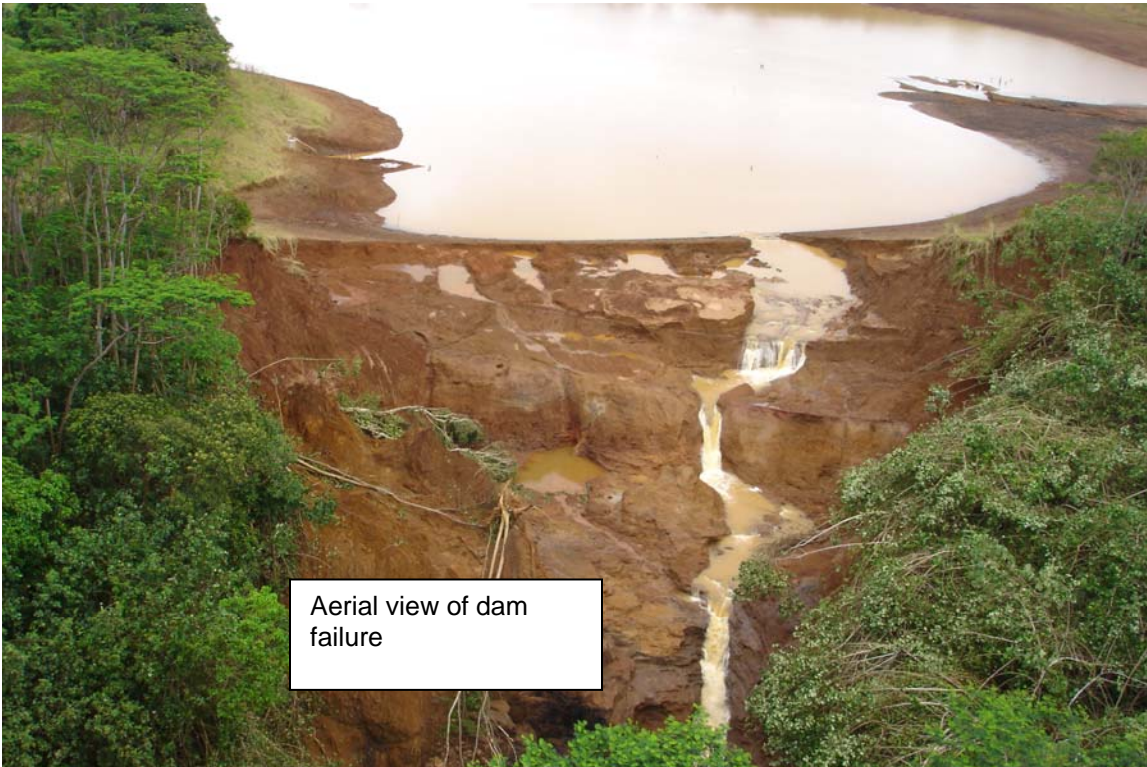
Dam breached 14 MAR 06. On the date of this limited visual inspection, there appeared to be no further immediate threat to the safety of the dam. No assurance can be made regarding the dam's condition after this date. Subsequent adverse weather and other factors may affect the dam's condition.

Aerial view of dam failure

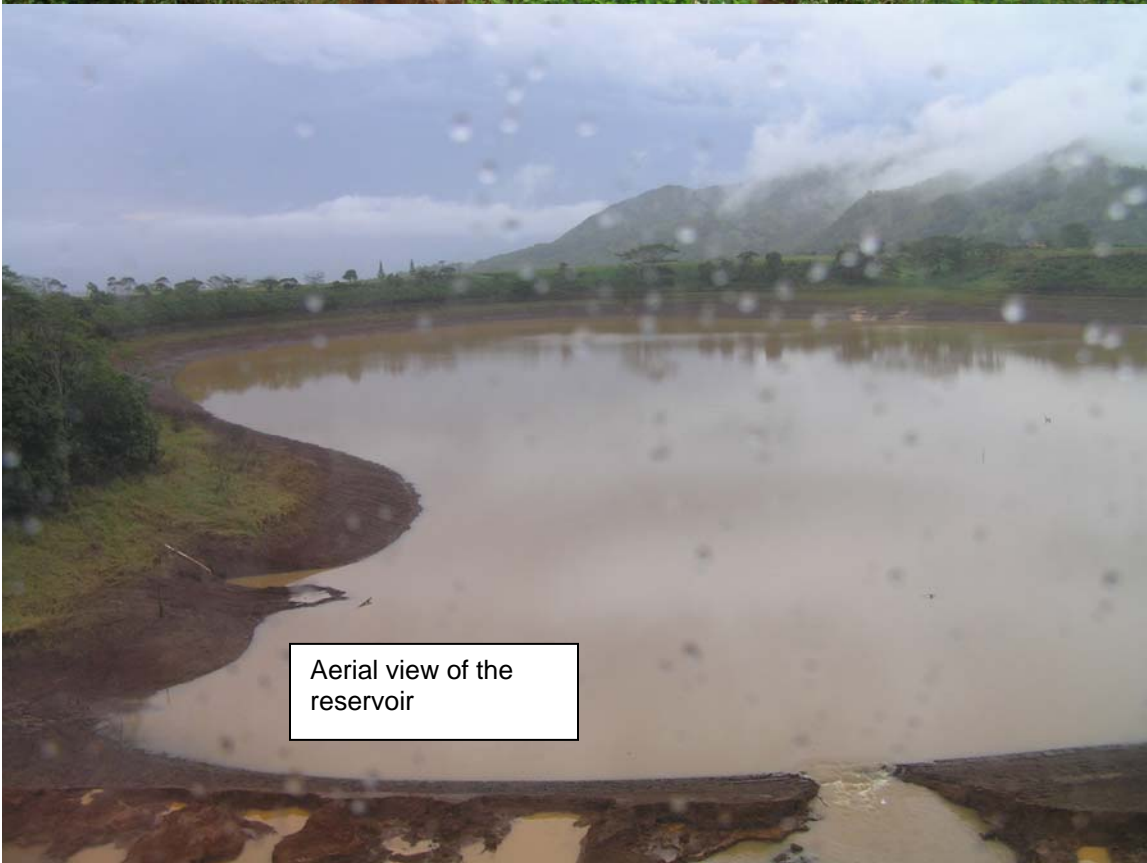
Aerial view of the reservoir

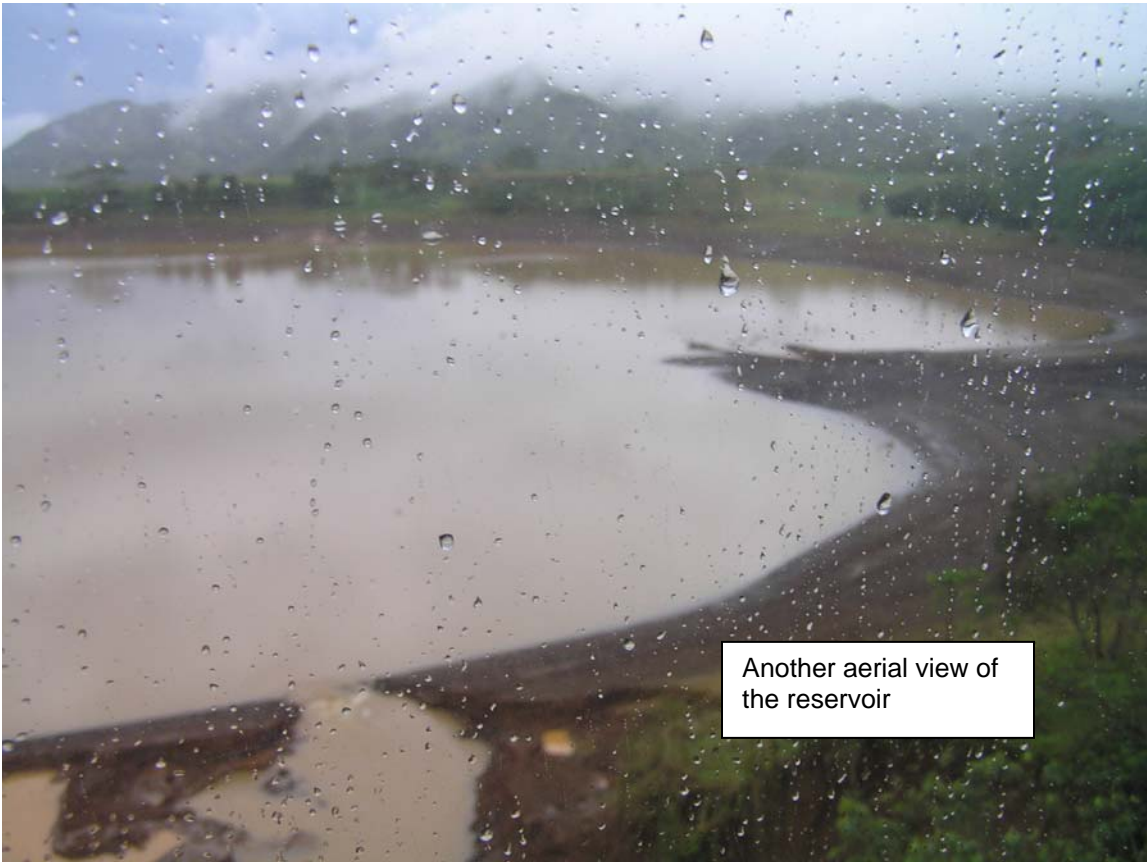
Another aerial view of the reservoir

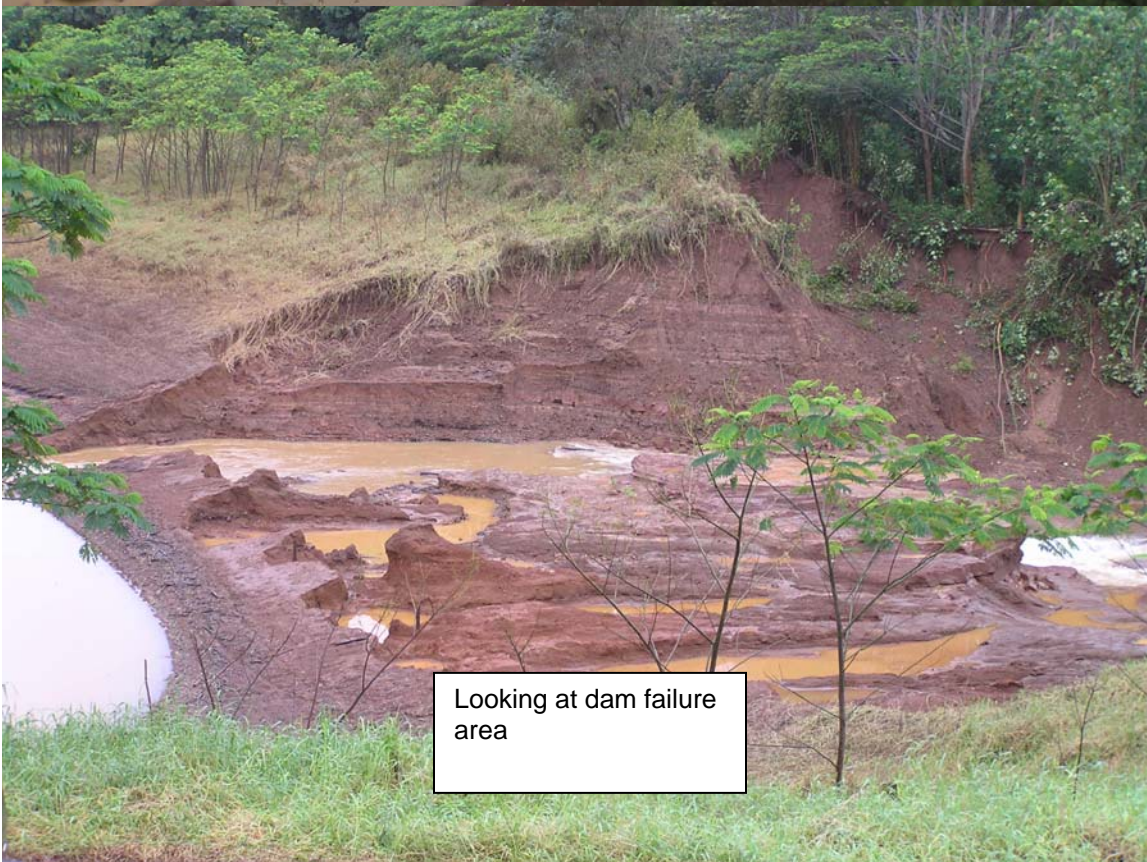
Sapprolite and highly weathered rock observed in failed dam area. This material is erodable; therefore recommend monitoring flow into the area for effects, especially during high rainfall periods. Re-assess at that point.

Looking at dam failure area

Short-term recommendation: Investigation and analysis by geotechnical professional engineer hired by the owner.
